# REVIEW OF LIGHTNING PROTECTION TECHNOLOGY FOR TALL STRUCTURES

Office of Naval Research  
National Aeronautics and Space Administration  
Federal Aviation Administration  
U.S. Air Force

(NASA-18-74177) REVIEW OF LIGHTNING  
PROTECTION TECHNOLOGY FOR TALL STRUCTURES  
(NASA) 286 p

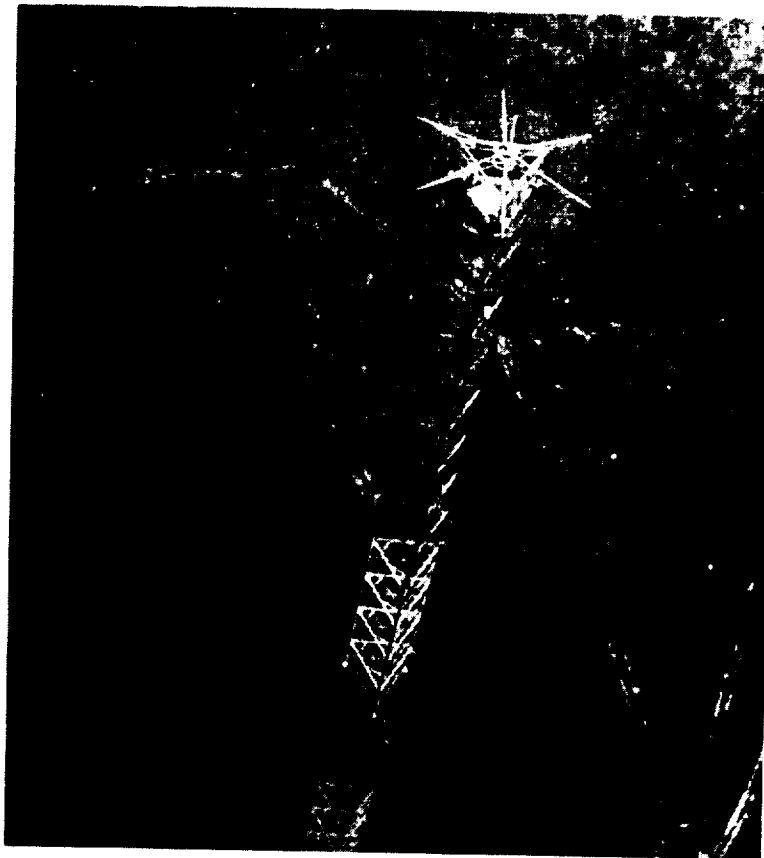
FIGURE 3, 1200-FOOT TOWER, C-9, EGLIN AFB, FLORIDA

In May 1973, LEA completed installation of an Umbrella Array System as illustrated by Figure 3. For the subsequent 15 months period, the system was instrumented and monitored continuously by Air Force personnel. No strikes were noted during this period; conversely, high dissipation currents were recorded regularly. Figure 4 presents a segment of one such chart; the dissipation current flow averaged 2200 microamperes during this period.

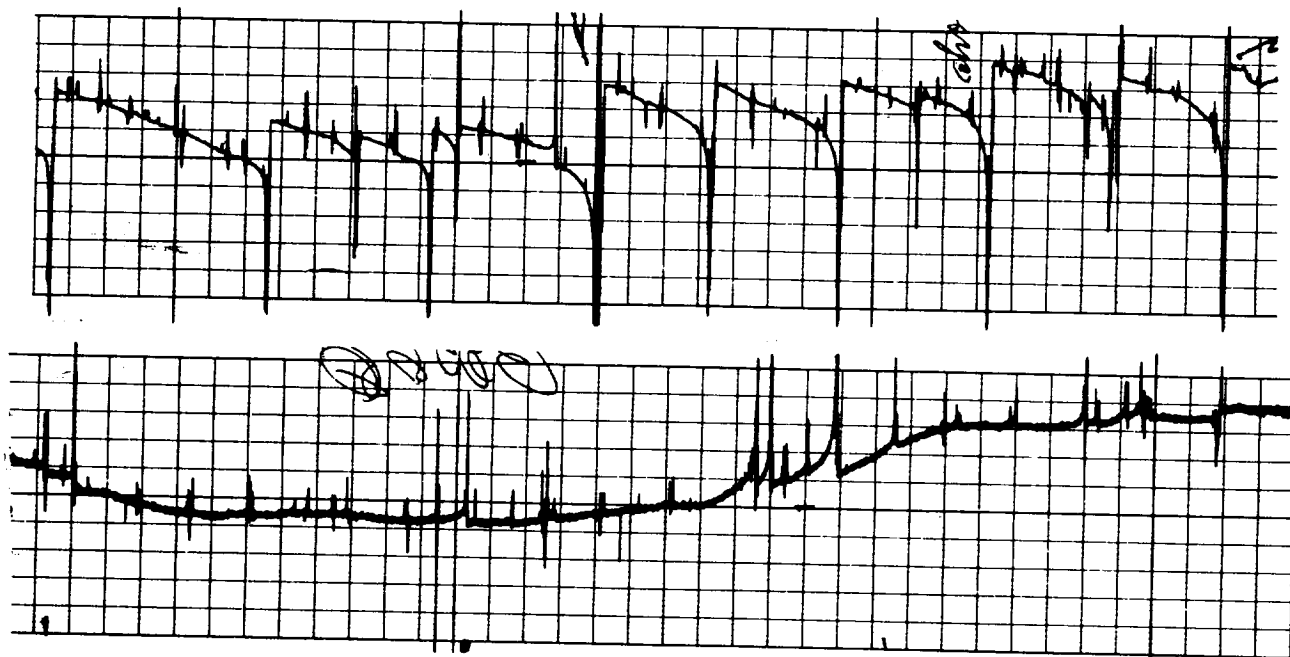
FIGURE 4, C-9, EGLIN AFB FLORIDA, DISSIPATION CURRENT HISTORY

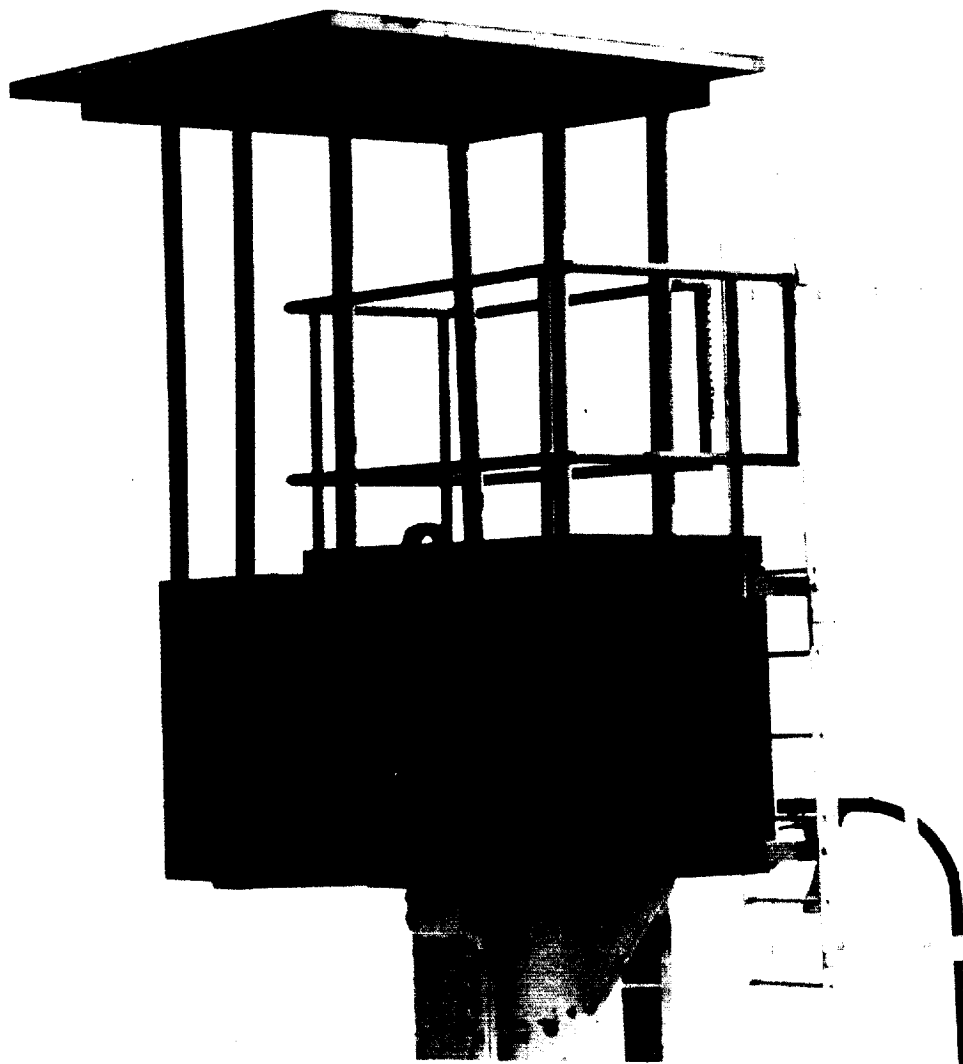
MOBILE SERVICE STRUCTURE, ARRAY #3

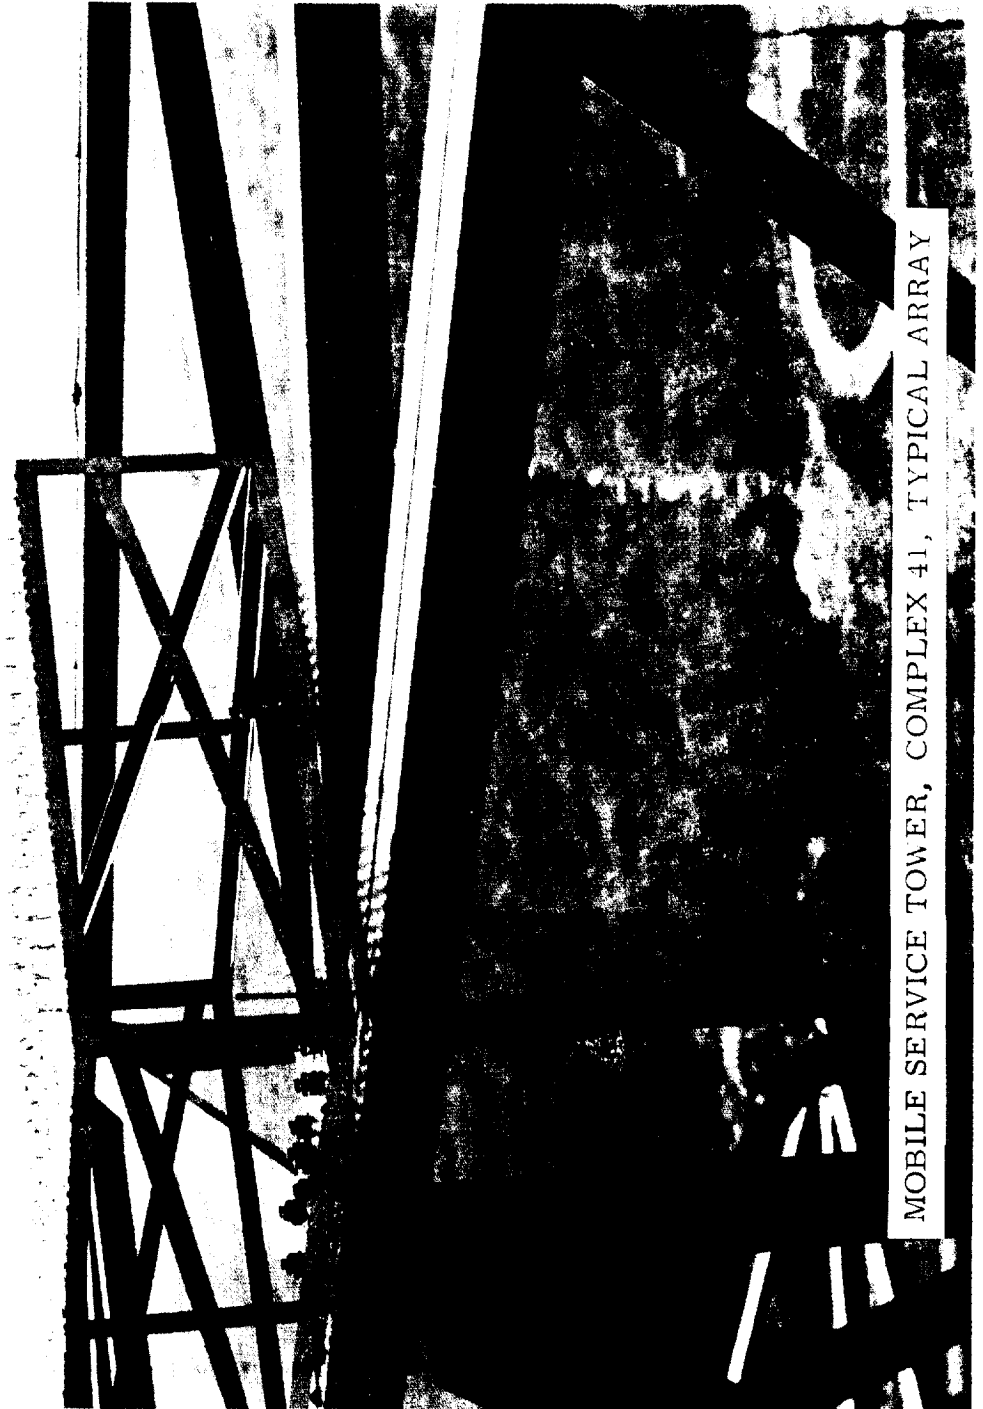
MOBILE SERVICE TOWER, COMPLEX 41, TYPICAL ARRAY

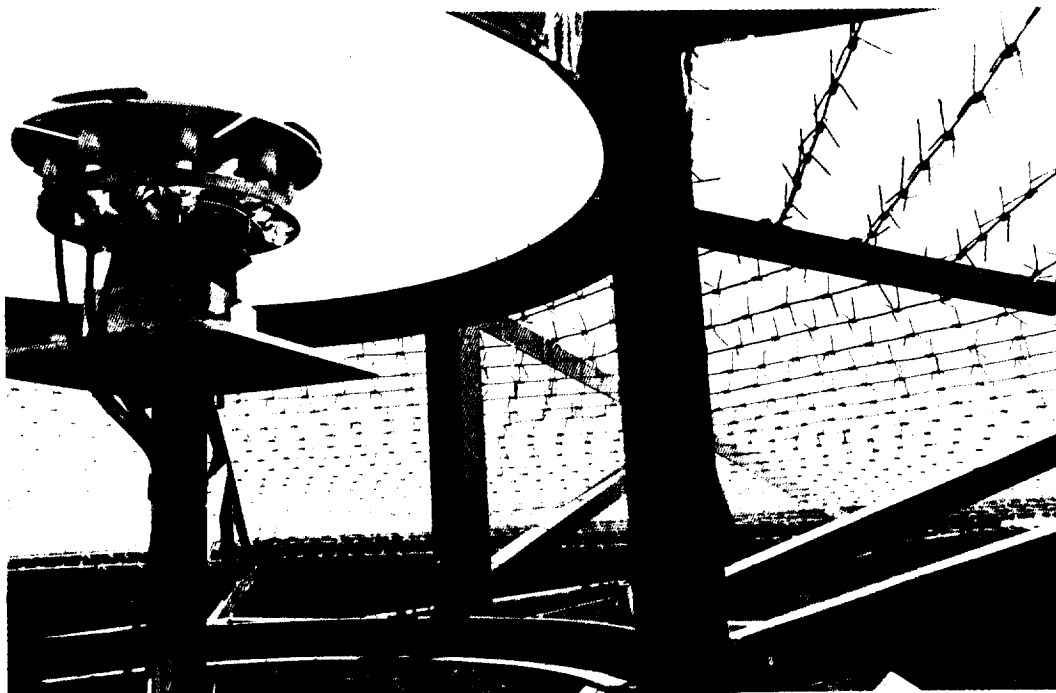
Figure 4. Close up of umbrella array at MILA

The dissipating wire is the material used to form the umbrella array, the truncated cone and the barrier types of arrays, whereas the rigid conducting material forms a disc or panel array. Figure 3 shows an umbrella array installed on a 100 foot collimation tower at NASA/GSFC's satellite tracking station on Merritt Island, Florida. The array is approximately 20 feet in diameter and is comprised of the dissipating wire wrapped spirally around the "umbrella" framework. A close-up of the array is shown in Figure 4. Approximately 1000 feet of the dissipating wire is used in such an array.

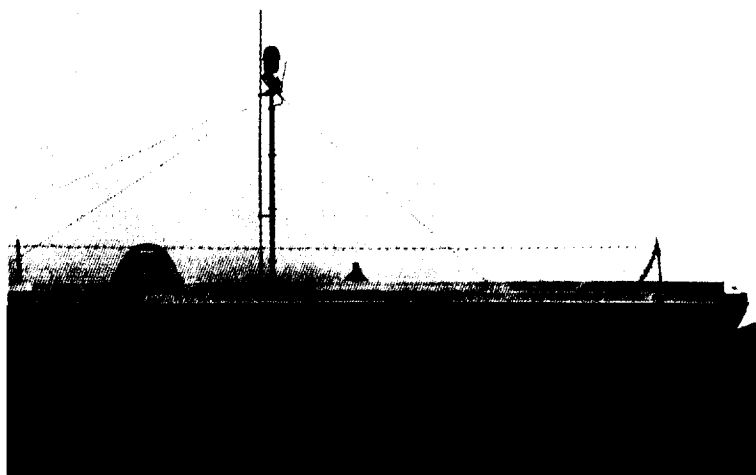
Figure 8.  
Panel array at  
site C74  
Eglin A. F. B.,  
Florida

The panel type of array is shown in Figures 8 and 9. Figure 8 shows a small panel atop a wooden pole at site C74 Eglin Air Force Base, Florida and Figure 9 shows a close-up of a panel on top of a 1200 ft tower at site C9 Eglin Air Force Base. The sharp points are easily visible on this panel which was one of three atop the tower; each panel measuring 4' x 6'.

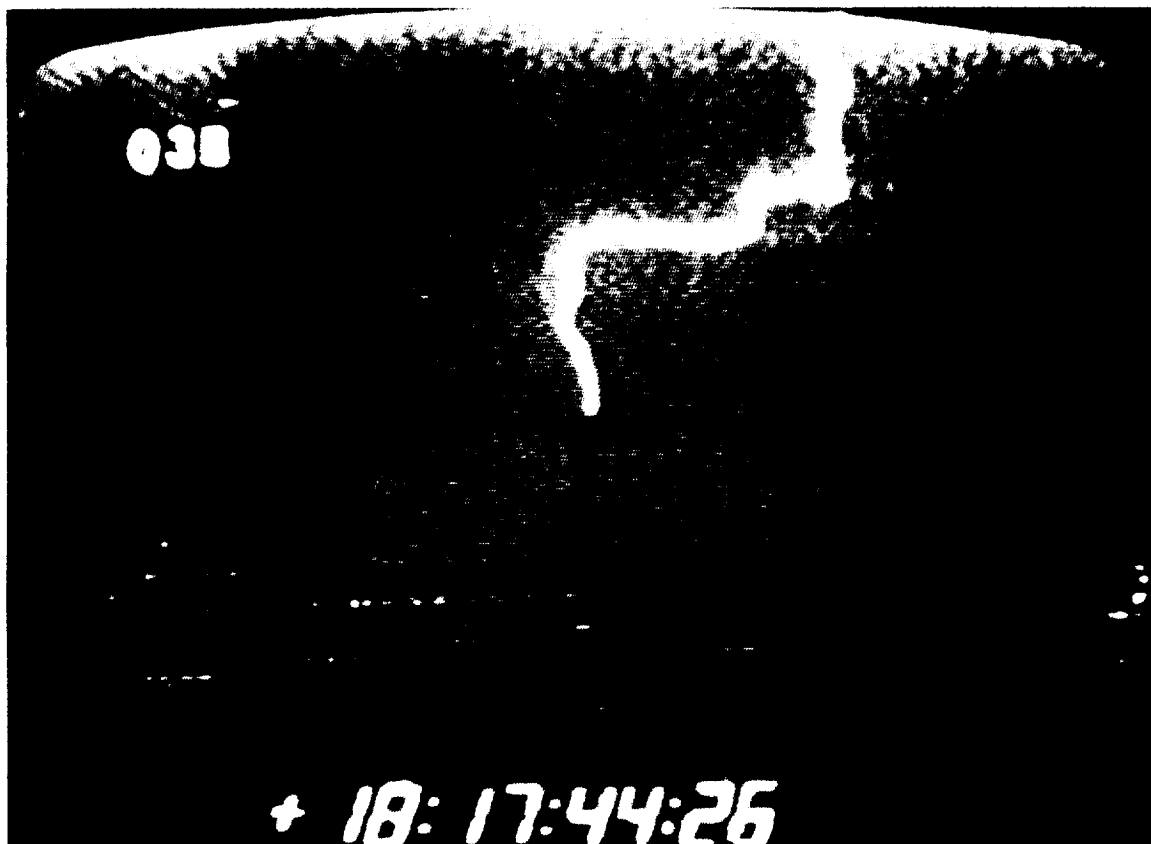
Figure 11.

Lightning striking a 500 foot meteorological tower at  
NASA's Kennedy Space Center, Florida, and hitting  
the dissipation array

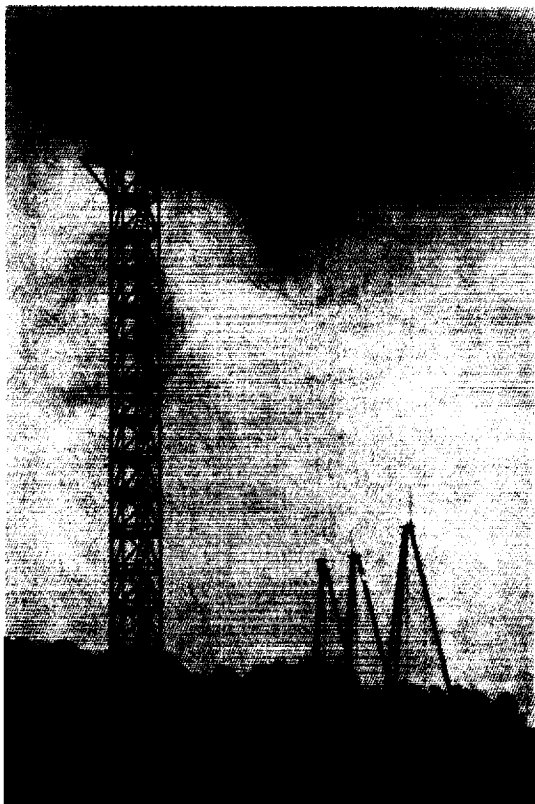
Figure 13 a.

100 foot collimation tower and three  
20 ft tripods used in the investigation

Field mills were erected at 4 heights: 100 feet (Fig 14), 20 feet and 5 feet (Fig 13c) and at ground level. Corona measurements were carried out at 100 feet from the dissipation array and at 20 feet from two different sources. Wind speed and direction were also monitored halfway up the tower at 50 feet (Fig 13a).

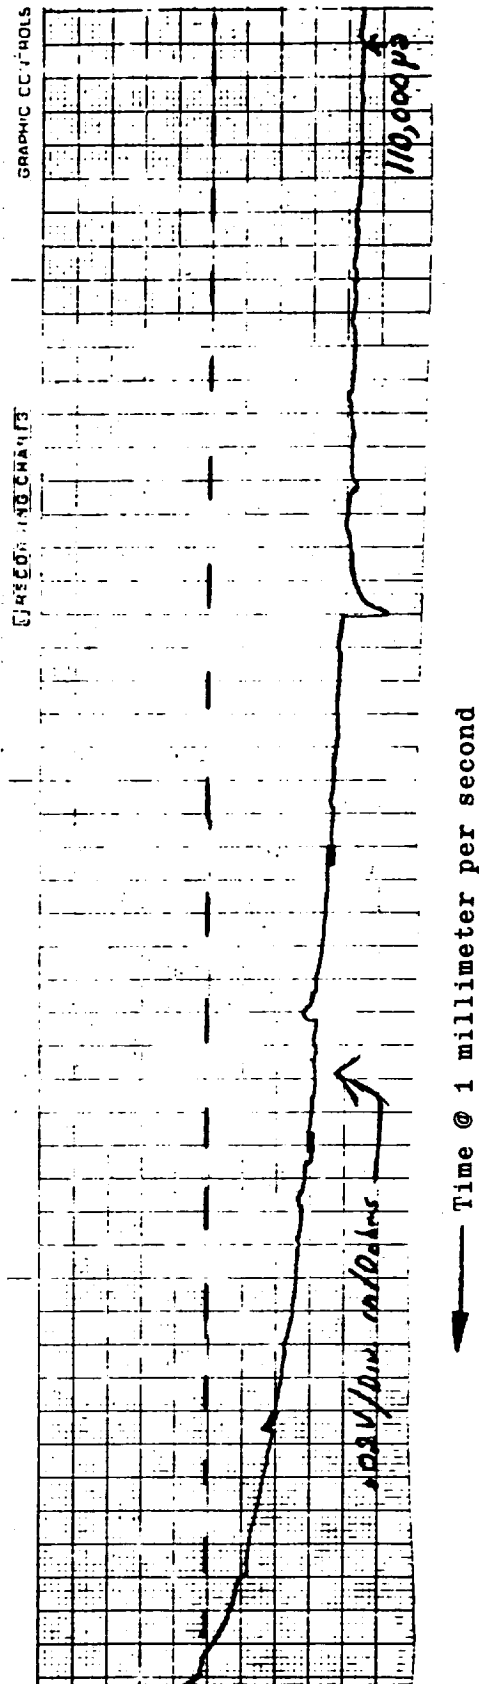
Figure 34. Corona current from 1200 foot tower dissipation array as reported in reference 16

Figure 34, also from reference (12) indicates a surprisingly large peak value of 110,000  $\mu$ A even though the markings of .02V/division and 10 ohms would indicate a current of 44,000 A. Once more, time appears to be going the wrong way.
